**CLEAN WATER ACT COMPLIANCE INSPECTION
U.S. ENVIRONMENTAL PROTECTION AGENCY, REGION 5**

Legend Farms Dairy, LLC

Date of Inspection: April 20, 2017 - April 21, 2017

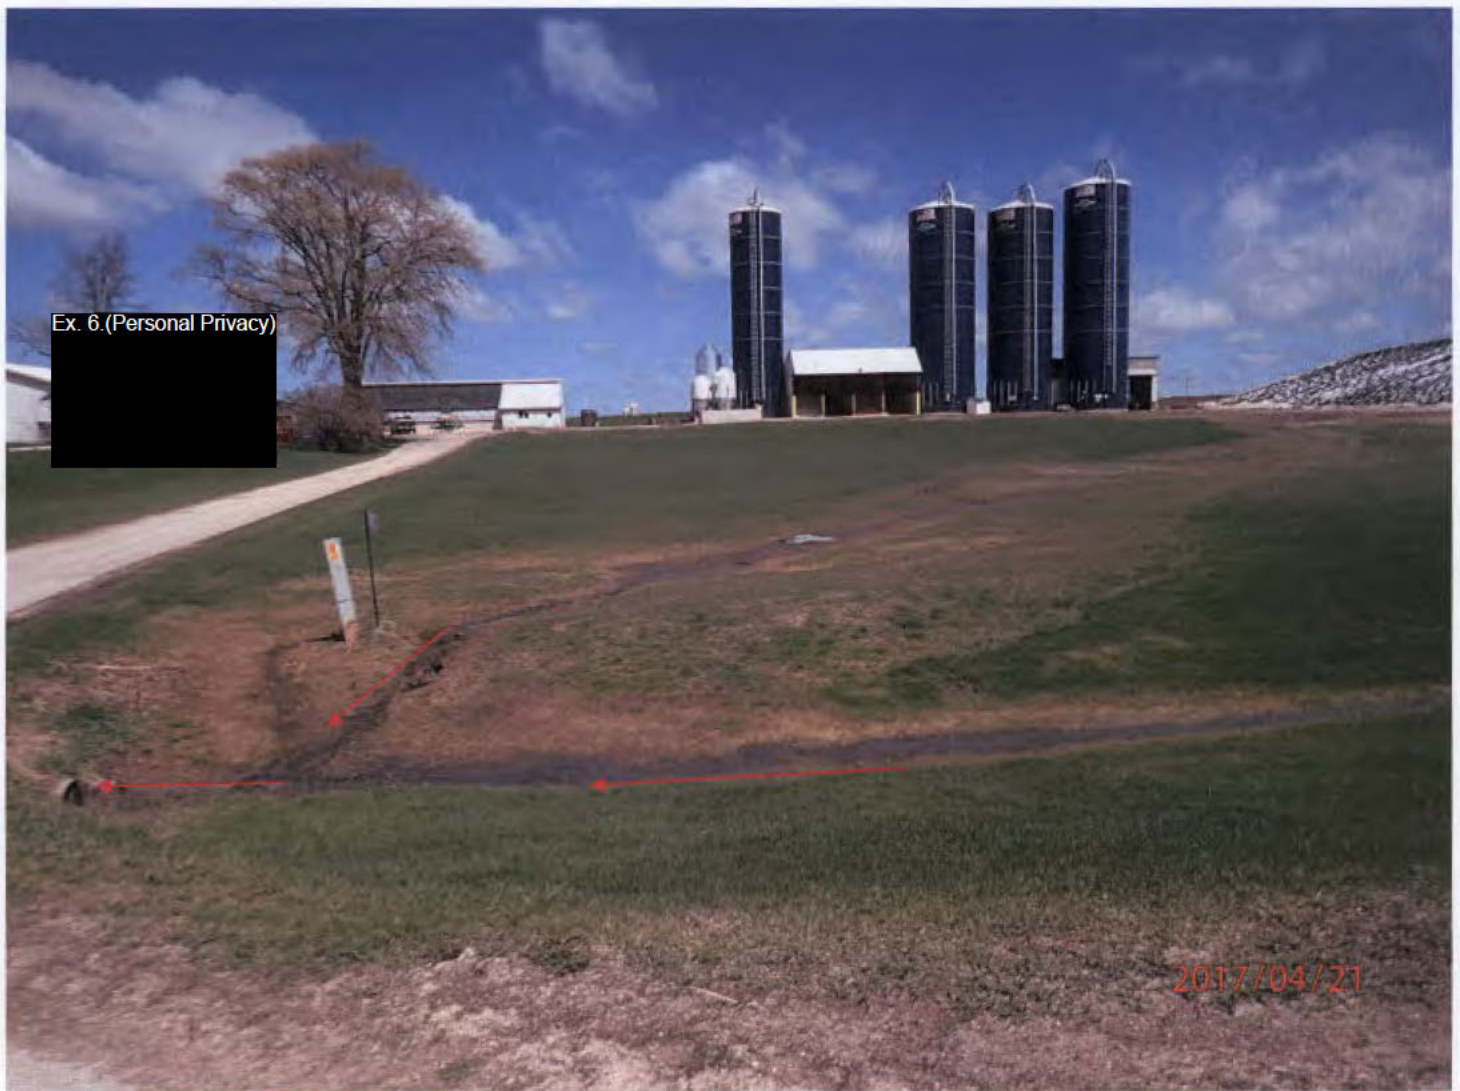
Photo: P4210078

Description: EPA observed the two process wastewater pathways off of the east and west side of the silage pad flow through the culvert under 2nd driveway west of Lilac Lane. Arrows depict the direction flow of the process wastewater.

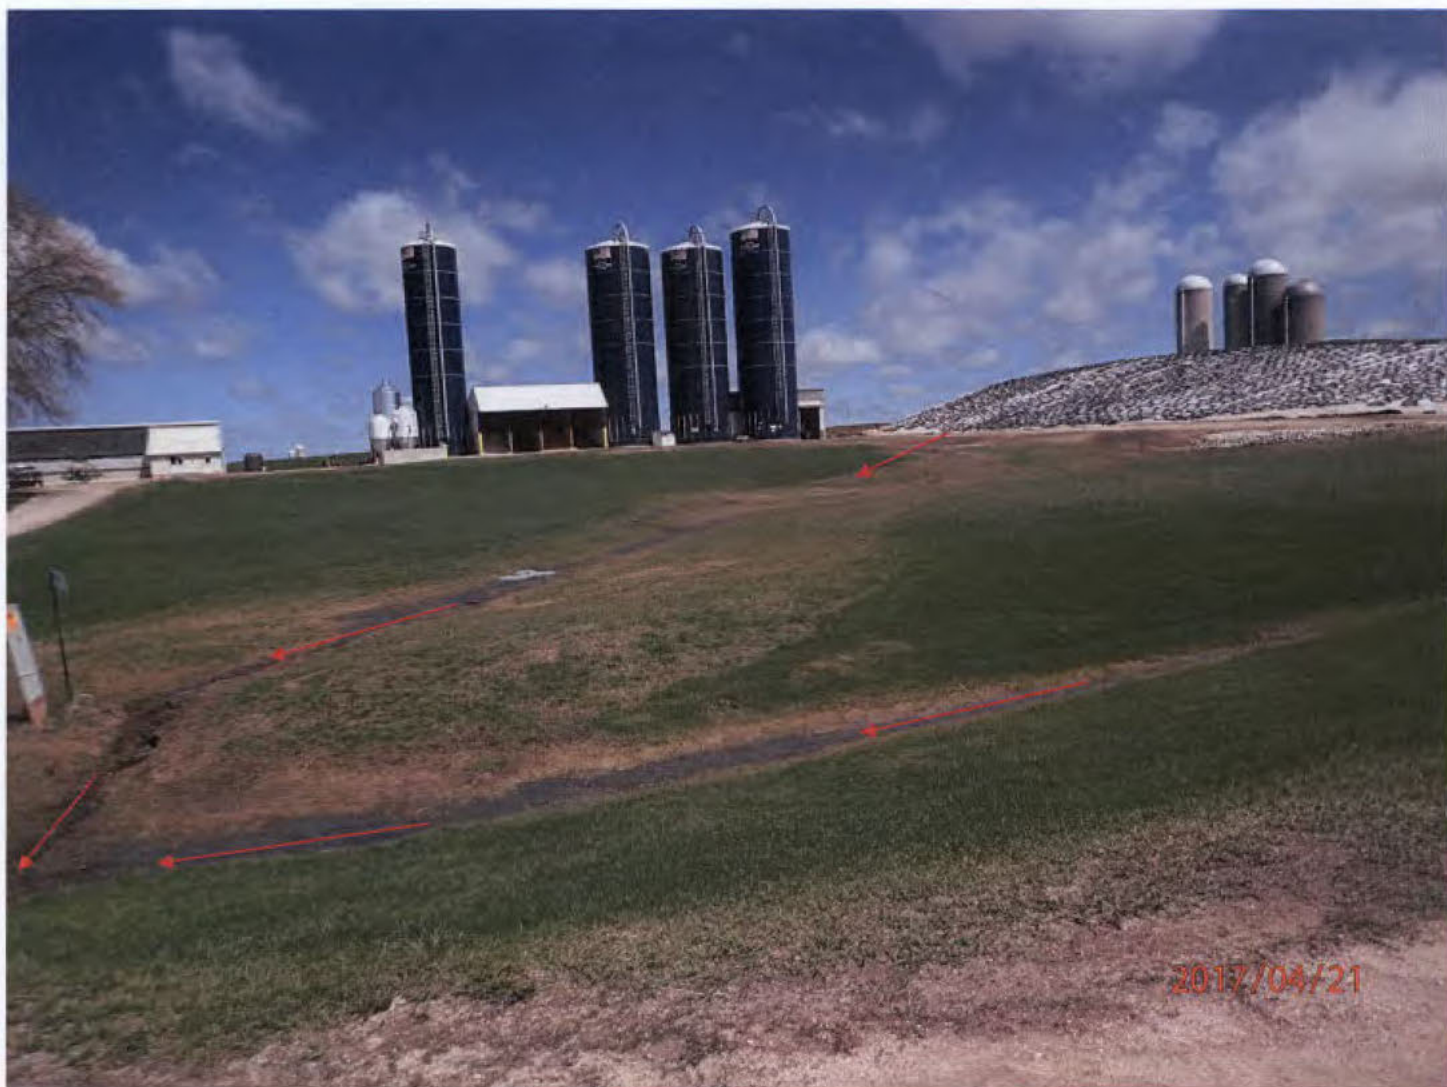
Photo: P4210079

Description: EPA observed the two process wastewater pathways one from the west side of the silage pad and one pathway from the east side of the silage pad flowing west on north side of County Road F converge and flow through the culvert under the 2nd driveway west of Lilac Lane.

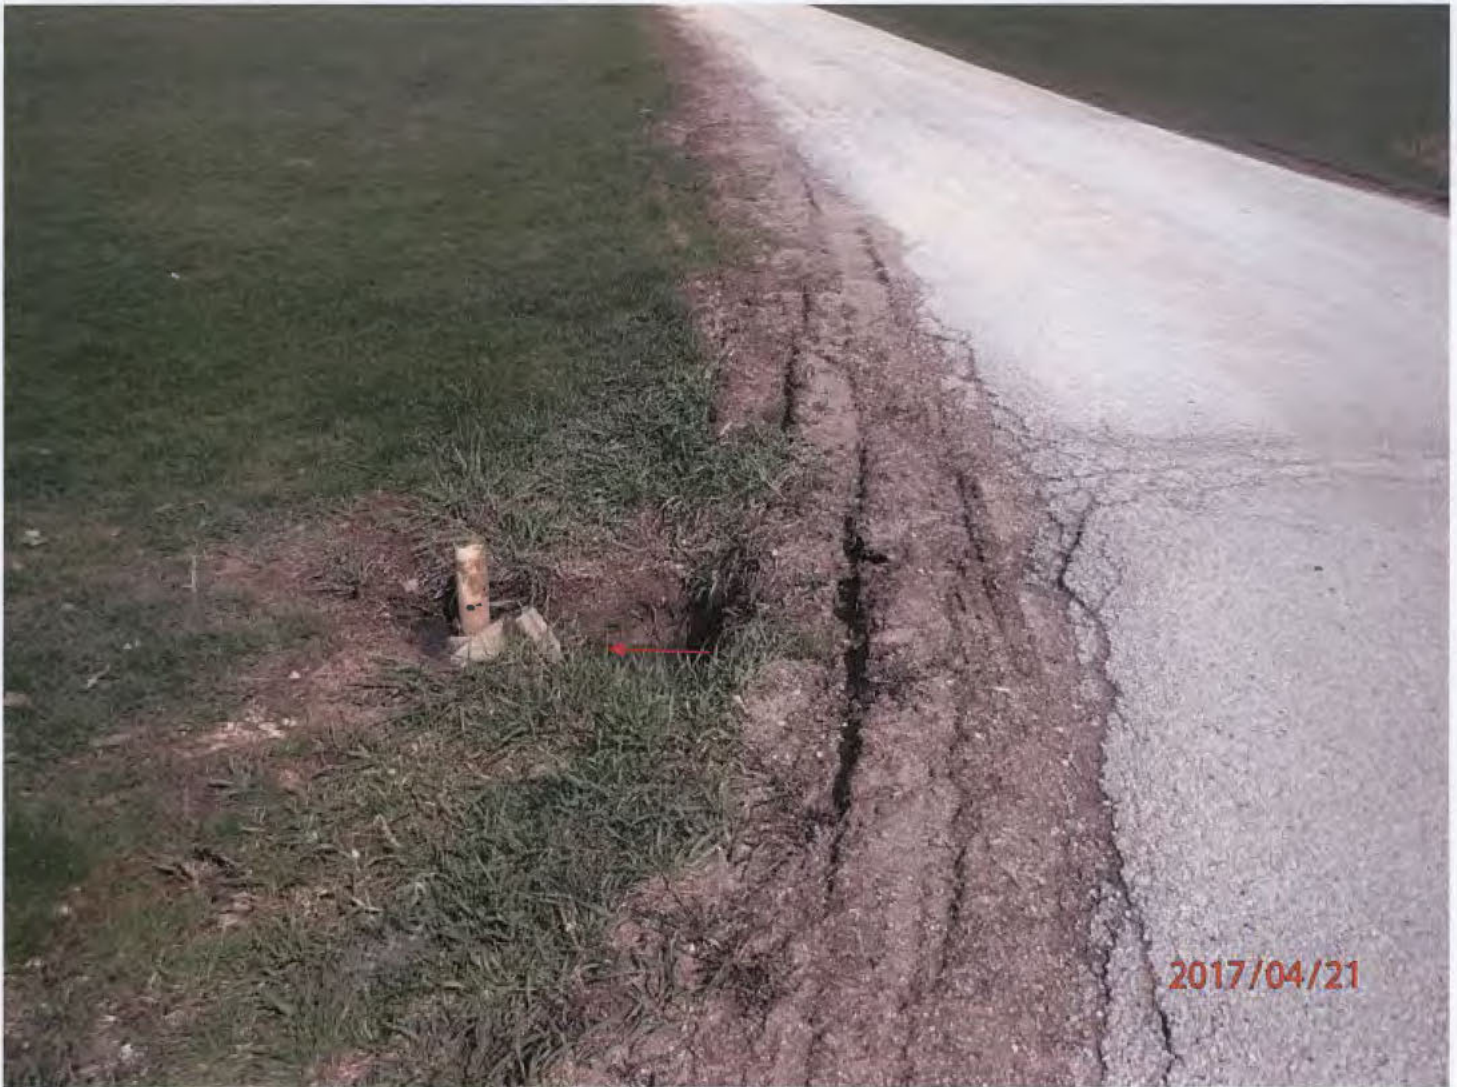
Photo: P4210080

Description: EPA observed the process wastewater flowing through the culvert under the 2nd driveway west of Lilac Lane into the tile inlet on the north side of County Road F. Arrow depicts the flow of process wastewater through the culvert under the 2nd driveway west of Lilac Lane.

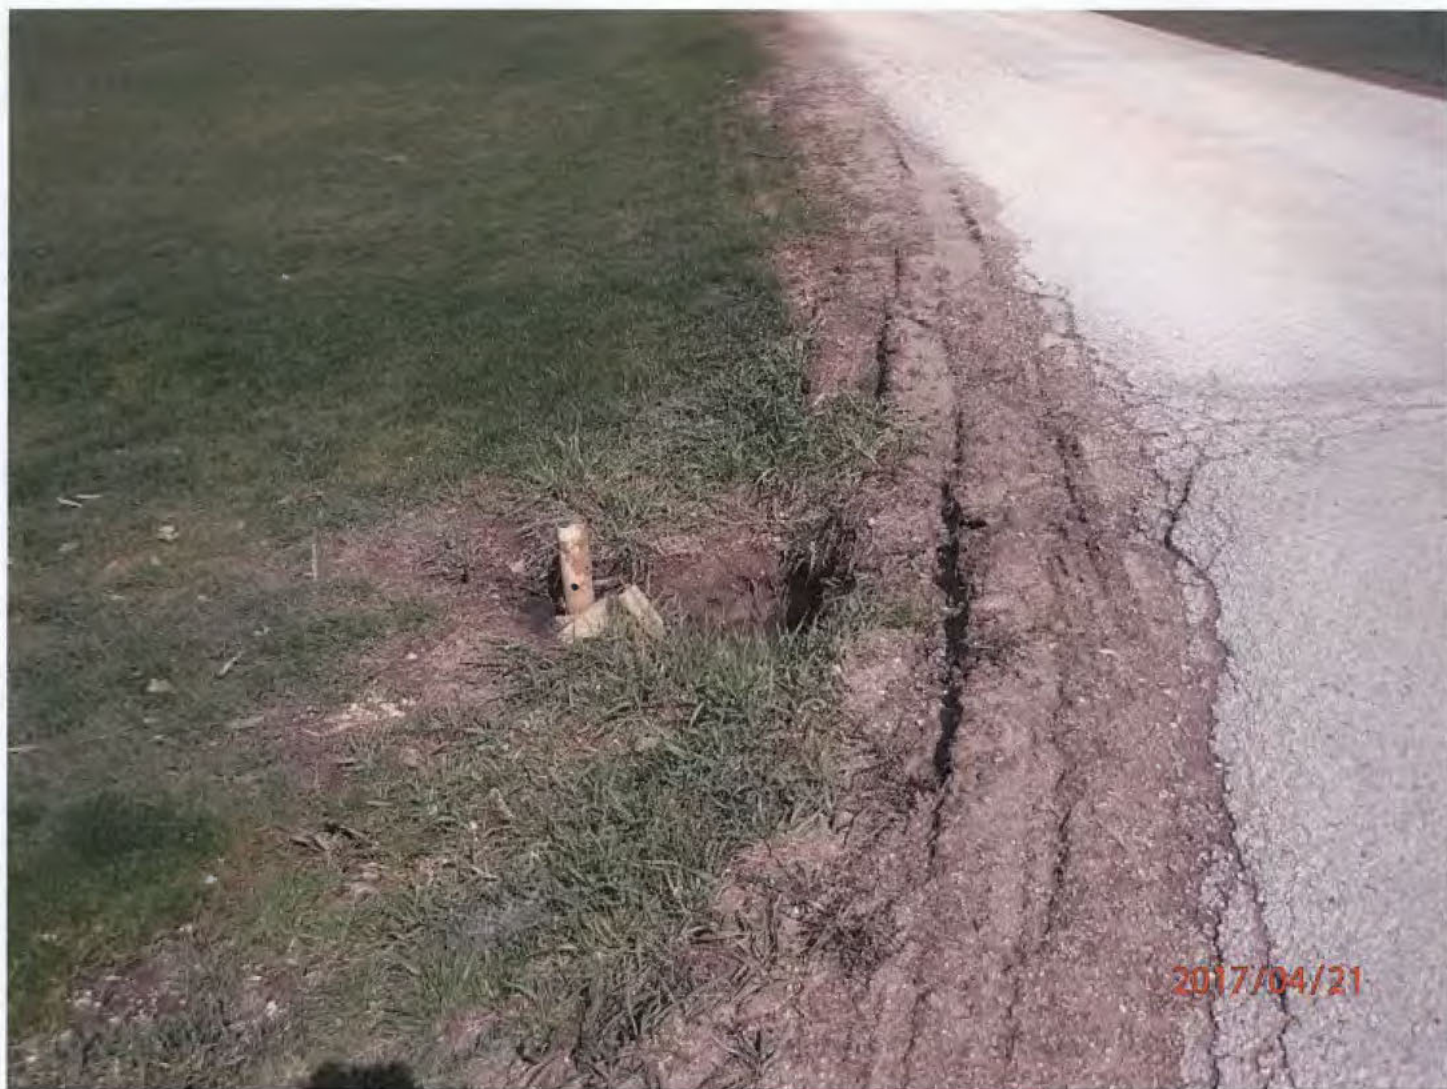
Photo: P4210081

Description: EPA observed the process wastewater flowing through the culvert under the 2nd driveway west of Lilac Lane into the tile inlet on the north side of County Road F.

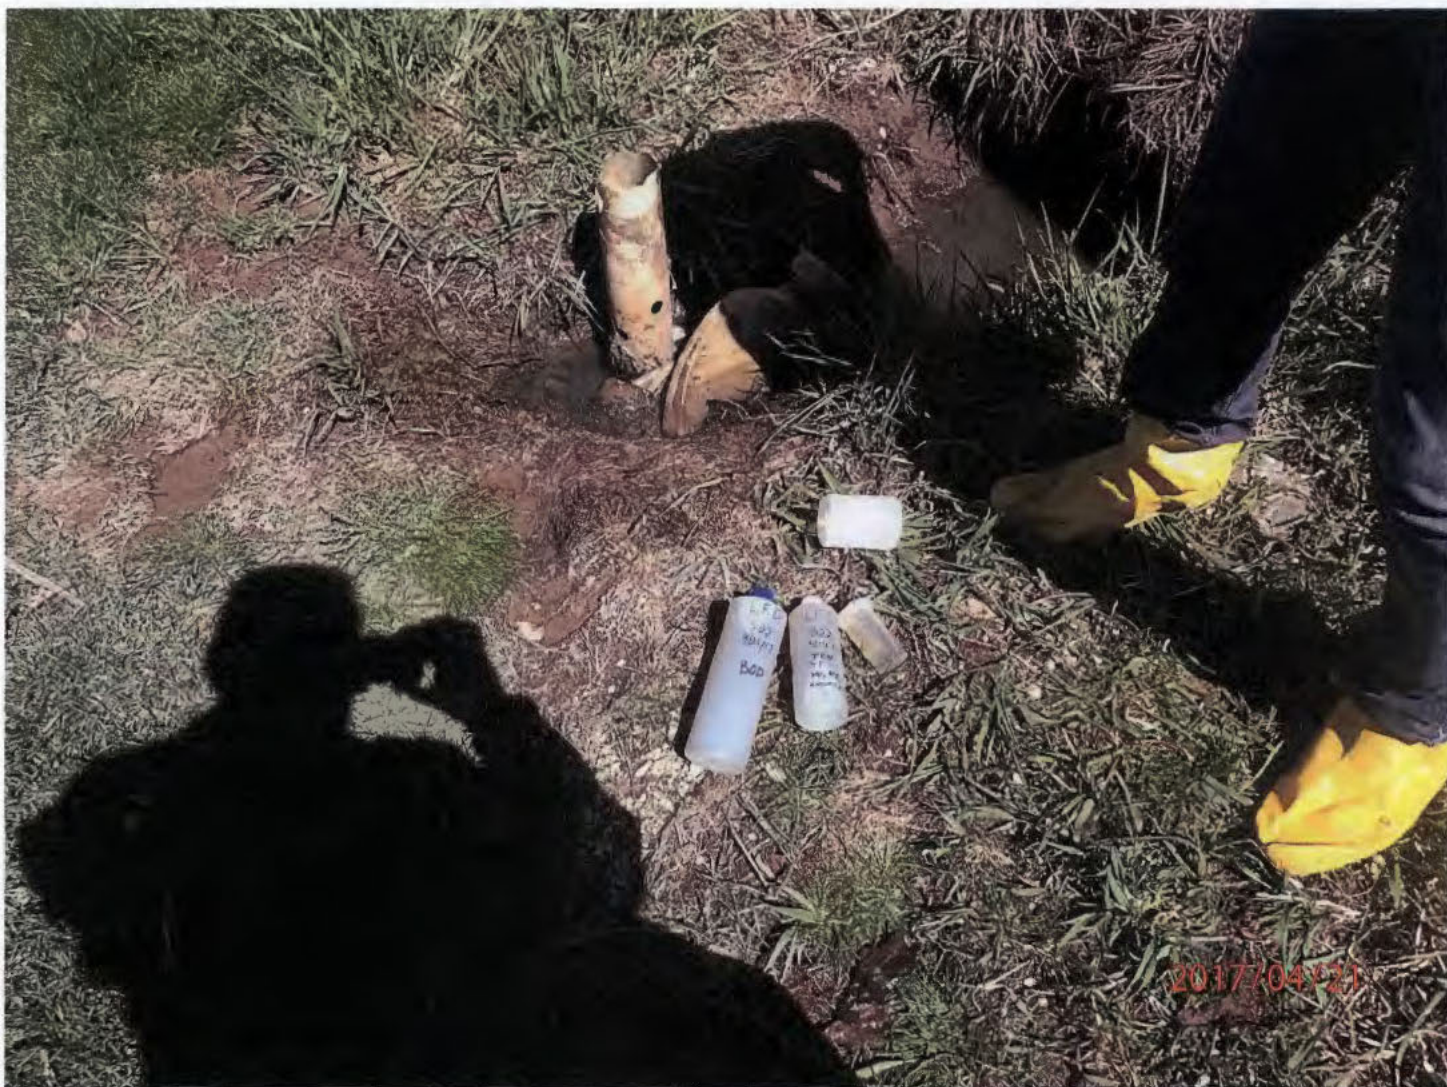
Photo: P4210083

Description: Sample S02- Culvert outlet on the west side of 2nd driveway west of Lilac Lane on the north side of County Road F before it flows into the tile inlet. EPA observed the flow into the tile inlet.

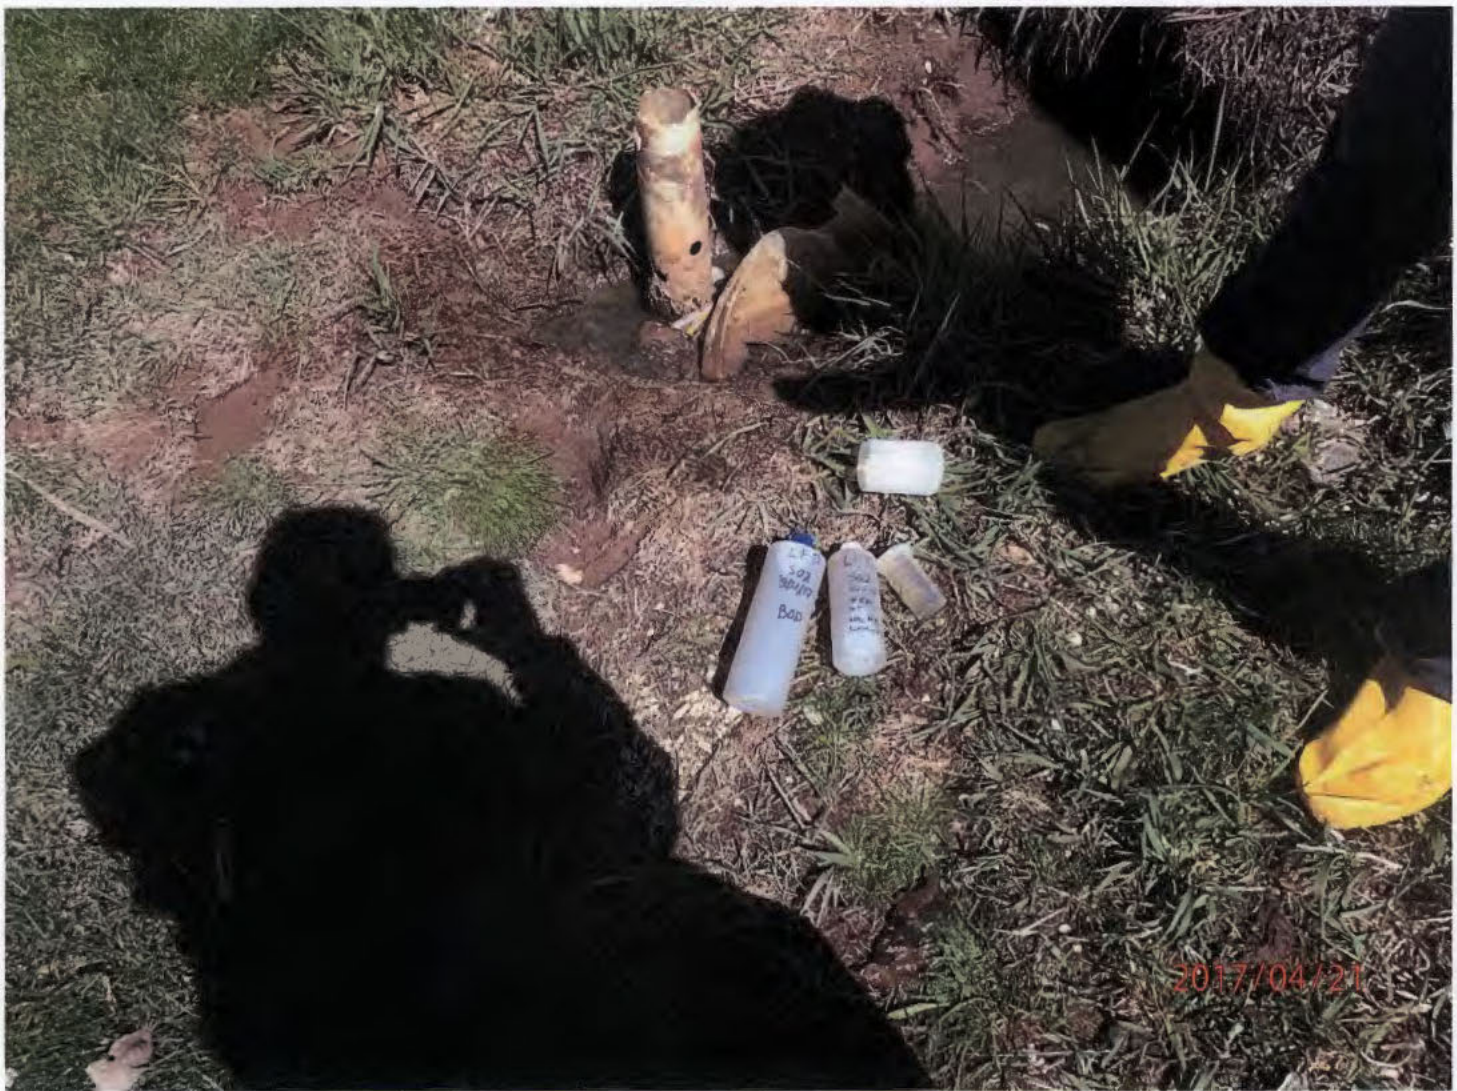
Photo: P4210084

Description: Sample S02- Culvert outlet on the west side of 2nd driveway west of Lilac Lane on the north side of County Road F before it flows into the tile inlet

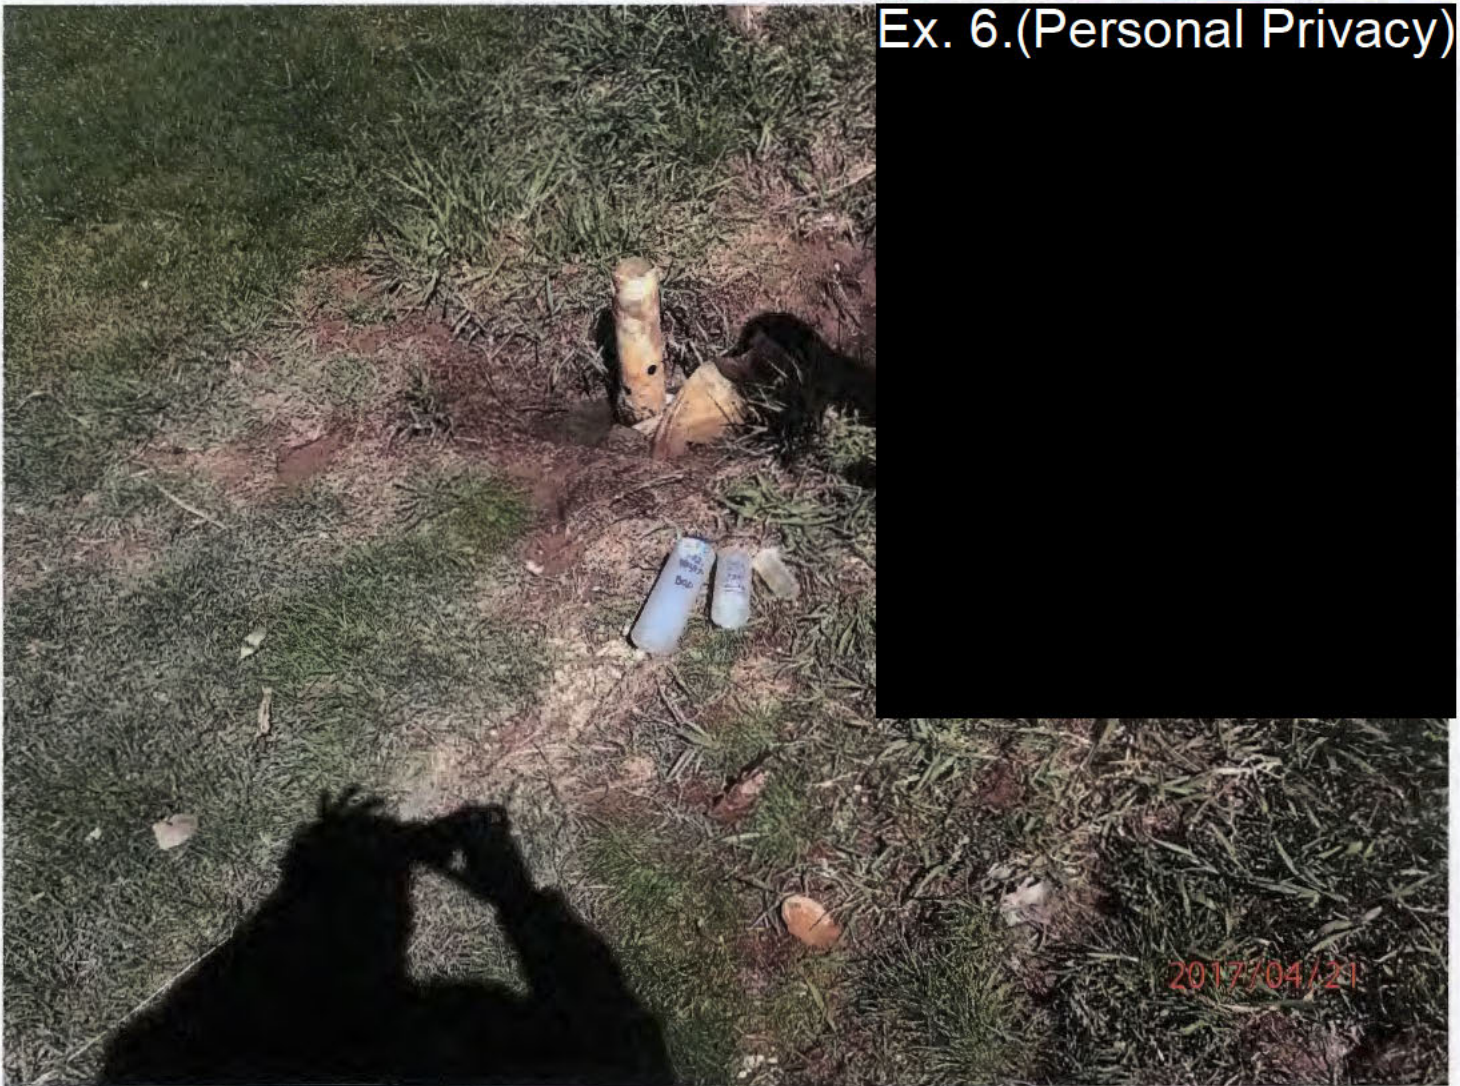
Photo: P4210085

Description: Sample S02 - Culvert outlet on the west side of 2nd driveway west of Lilac Lane on the north side of County Road F before it flows into the tile inlet.

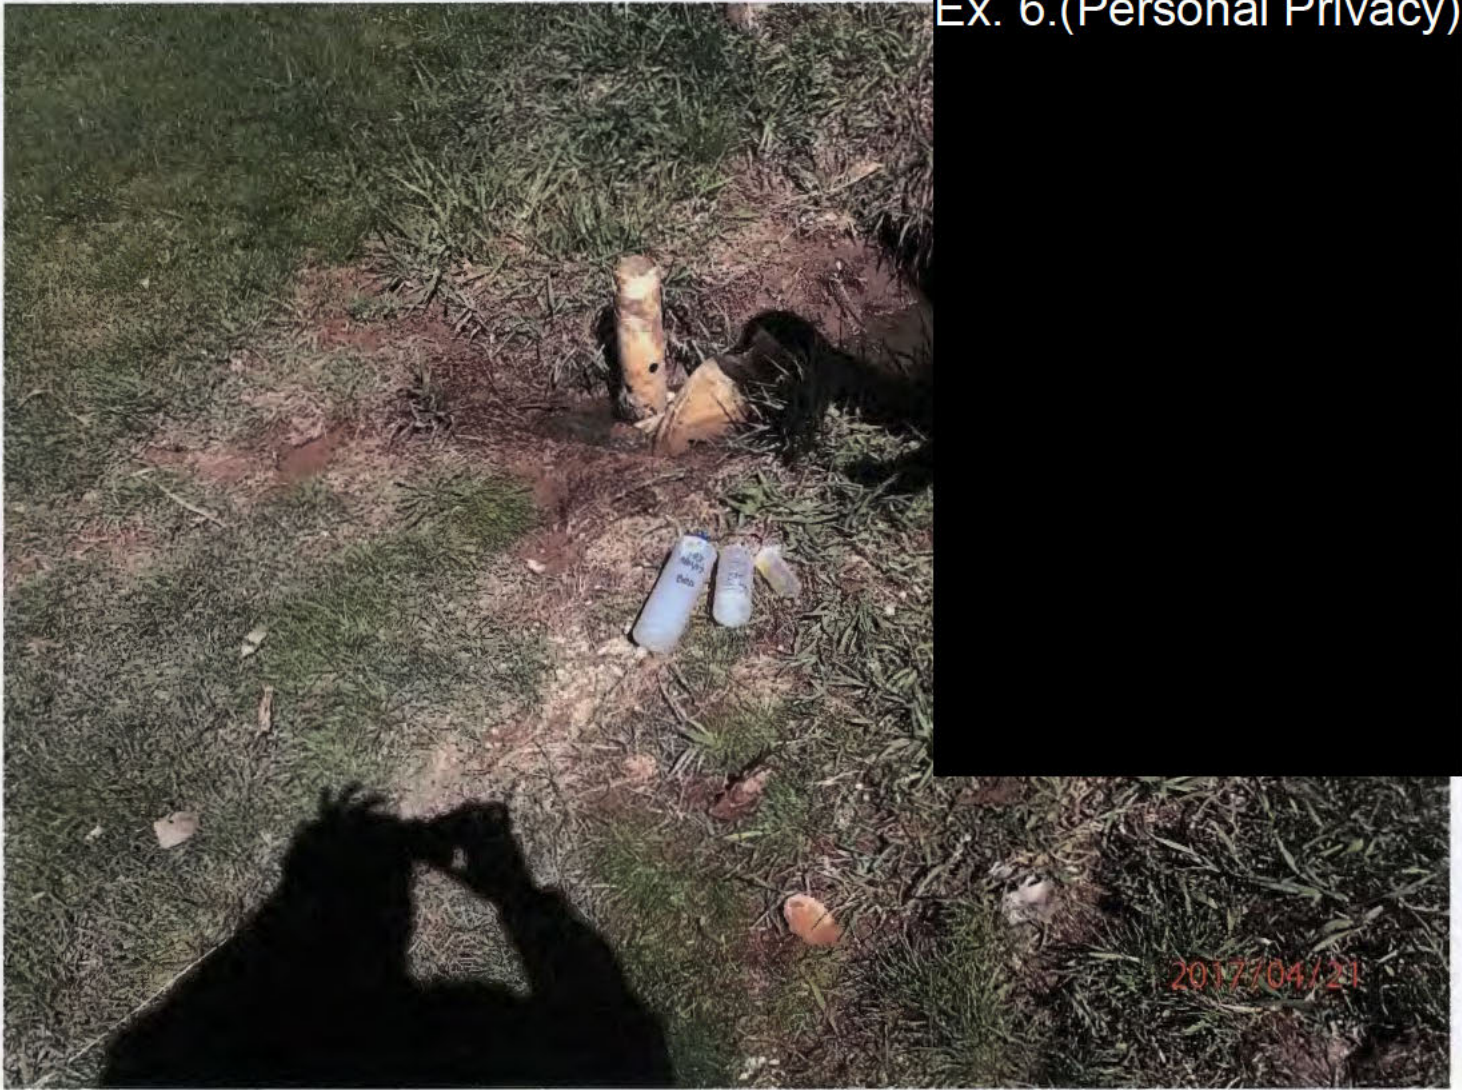
Photo: P4210086

Description: Sample S02 - Culvert outlet on the west side of 2nd driveway west of Lilac Lane on the north side of County Road F before it flows into the tile inlet.

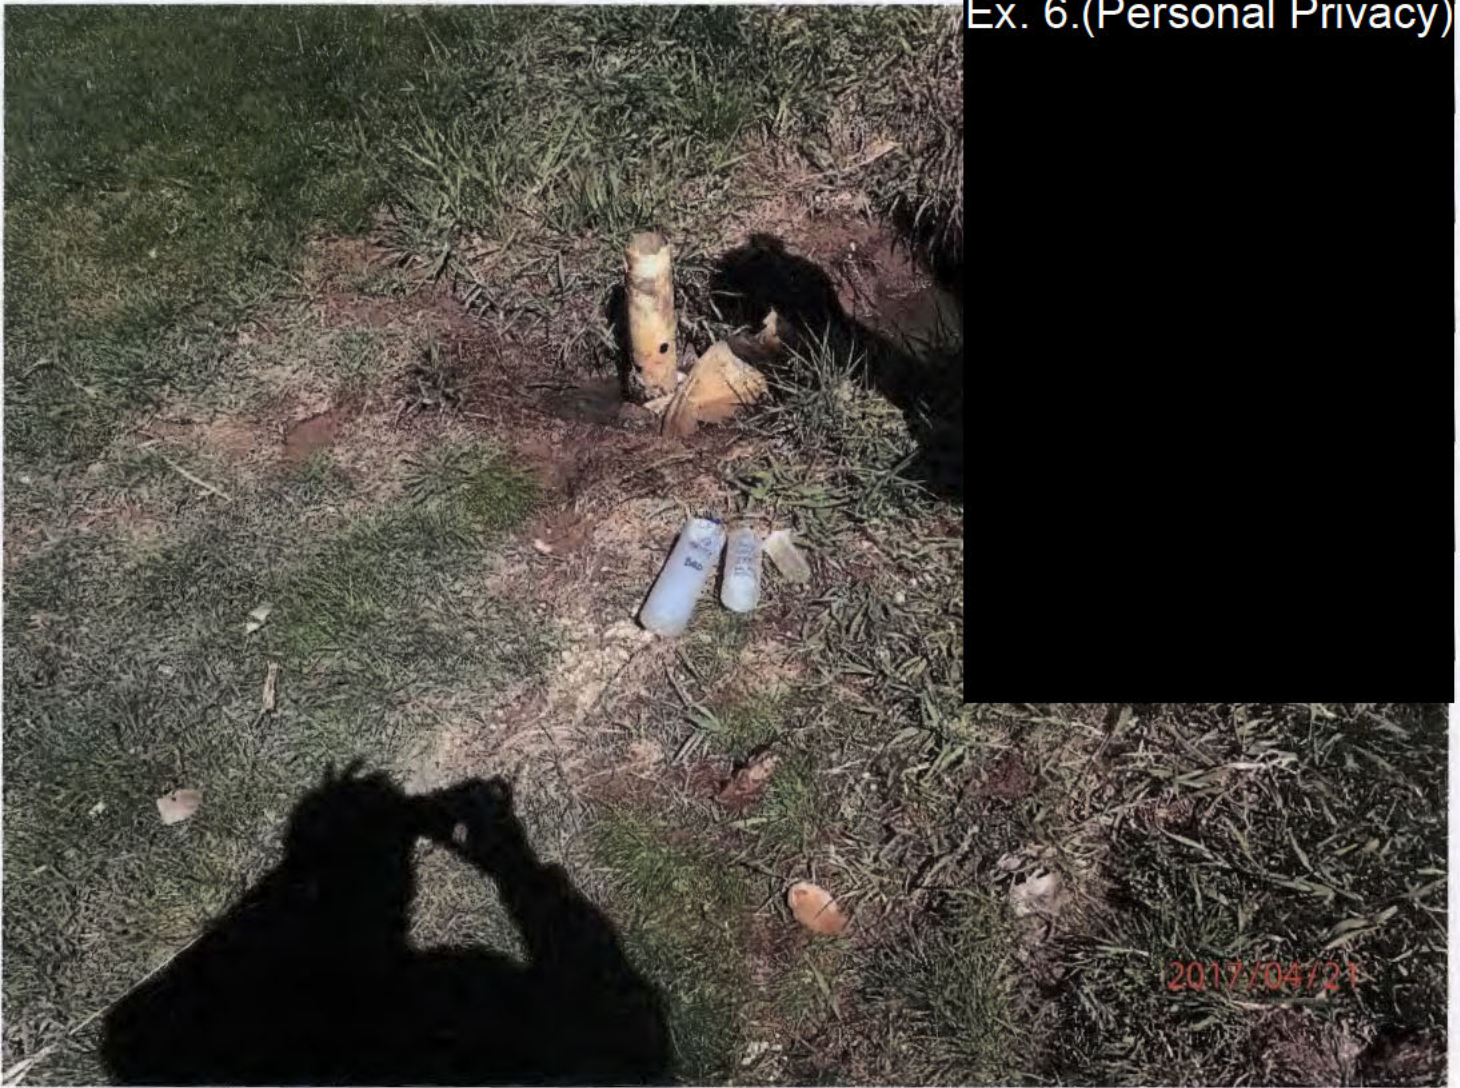
Photo: P4210087

Description: Sample S02 – Culvert outlet on the west side of 2nd driveway west of Lilac Lane on the north side of County Road F before it flows into the tile inlet

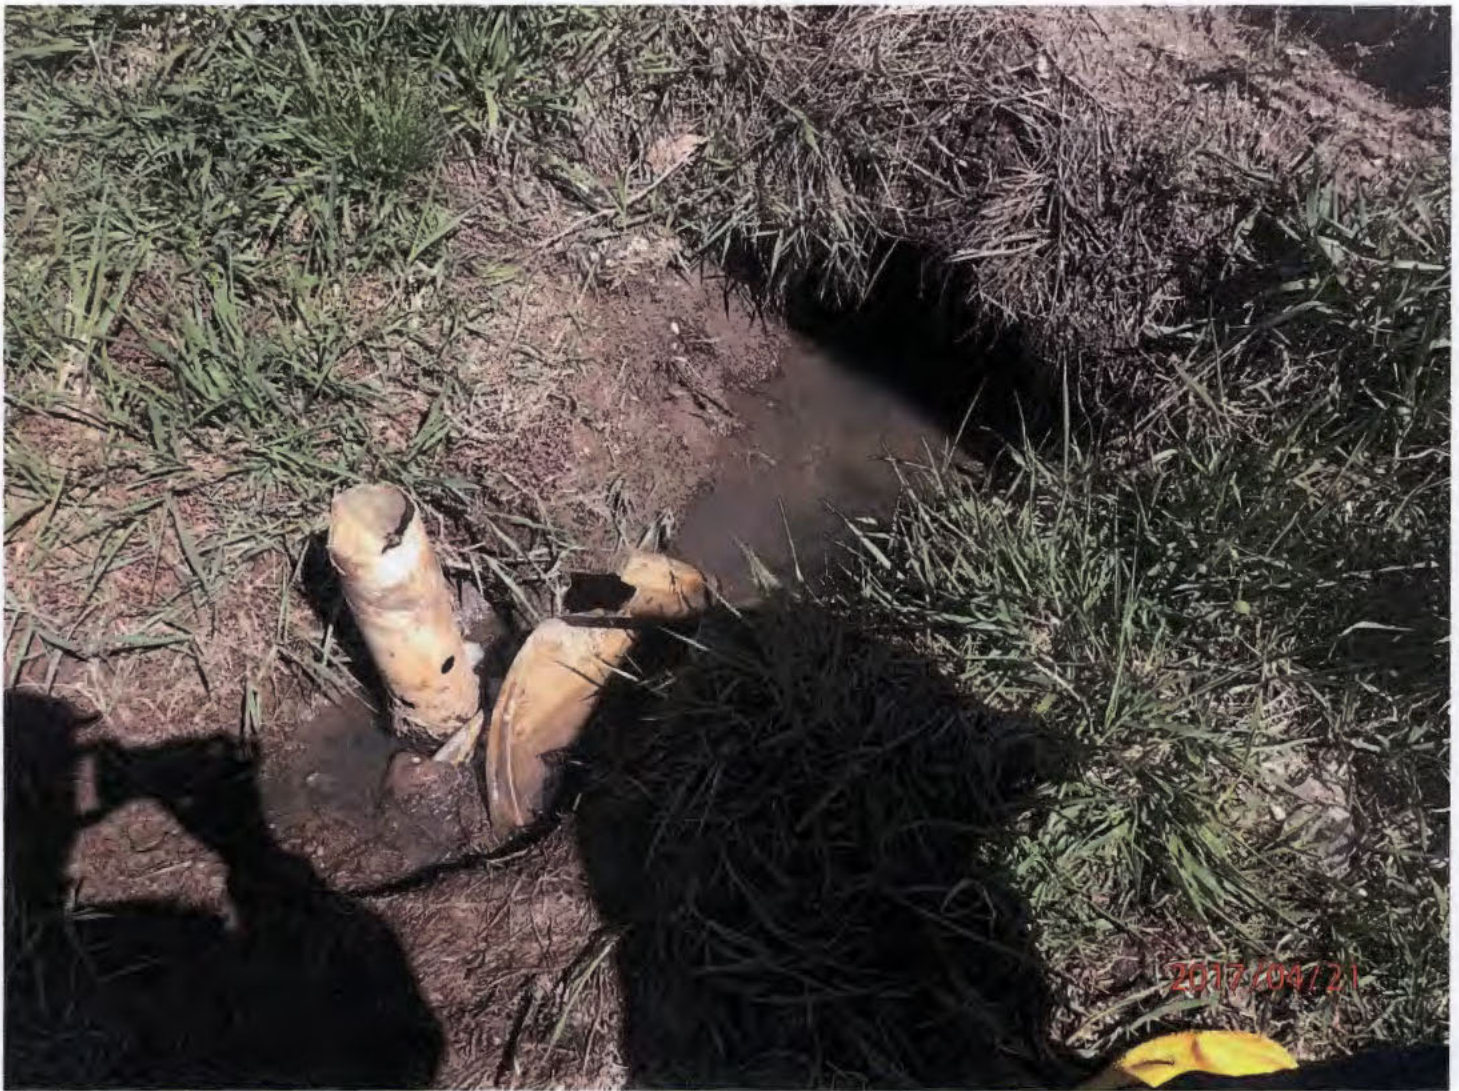
Photo: P4210088

Description: Close-up of the process wastewater as it flows out from the culvert outlet on west side of the driveway west of Lilac of the culvert outlet and tile inlet on the north side of County Road F and west of the 2nd driveway west of Lilac Lane.

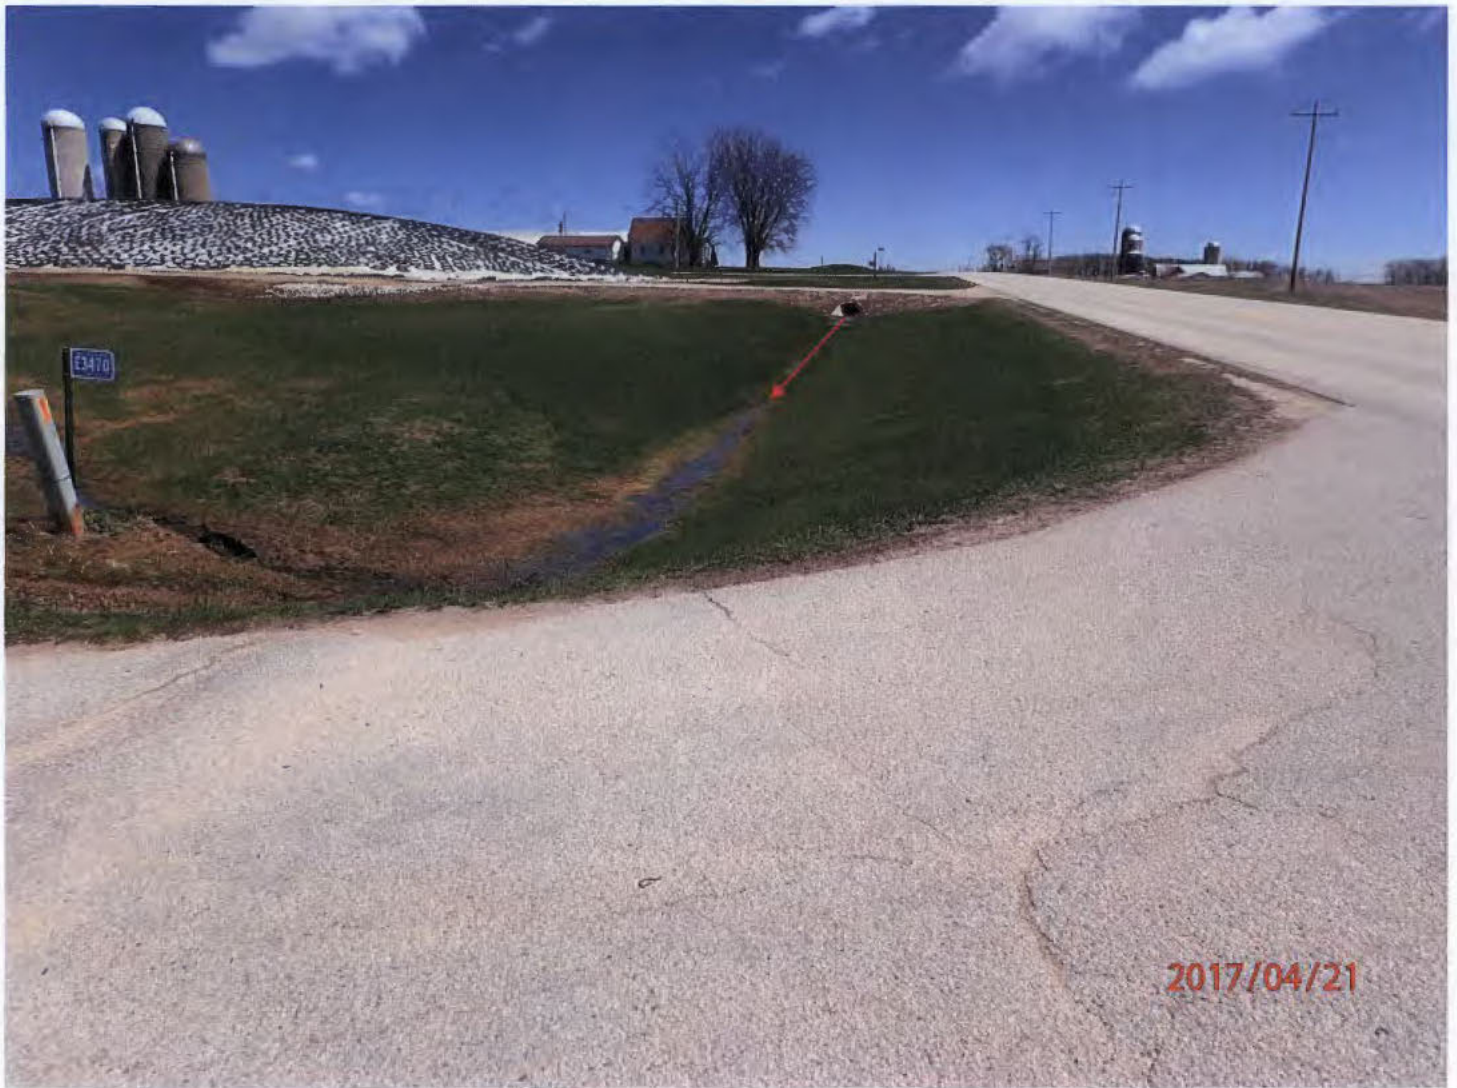
Photo: P4210089

Description: EPA observed the flow of process wastewater from in the roadside ditch on the north side of County Road F flowing west toward the 2nd driveway west of Lilac Lane

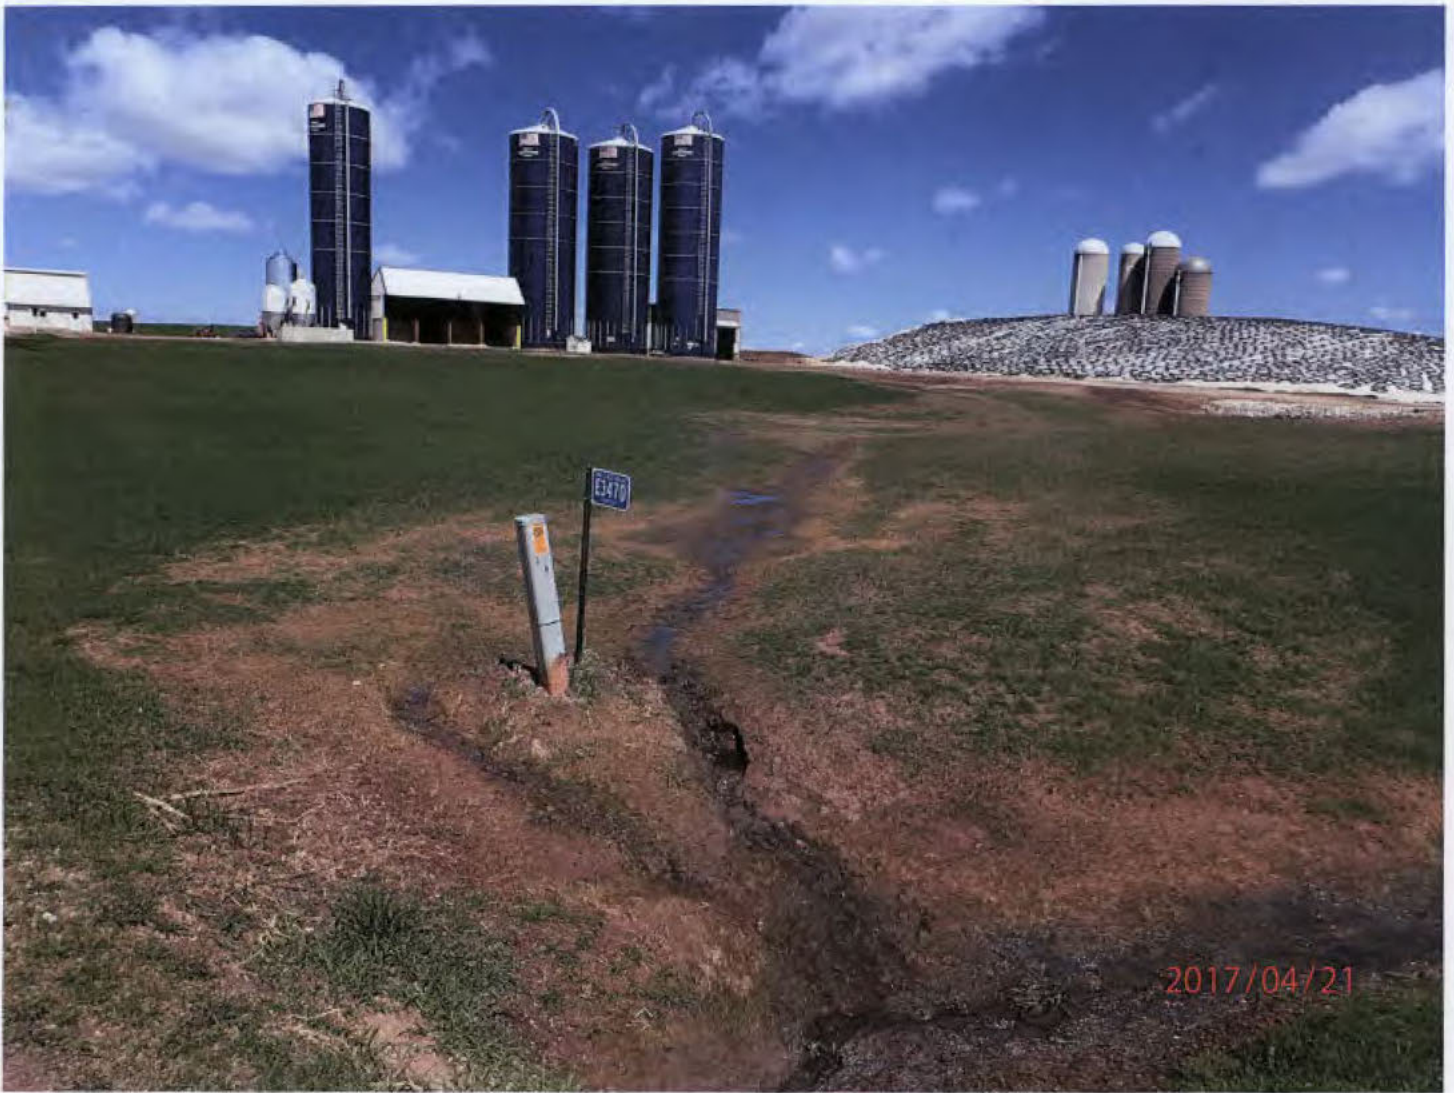
Photo: P4210090

Description: EPA observed the process wastewater discharging off of the west side of the silage pad discharging to the southwest into the culvert that flows under the 2nd driveway west of Lilac Lane.

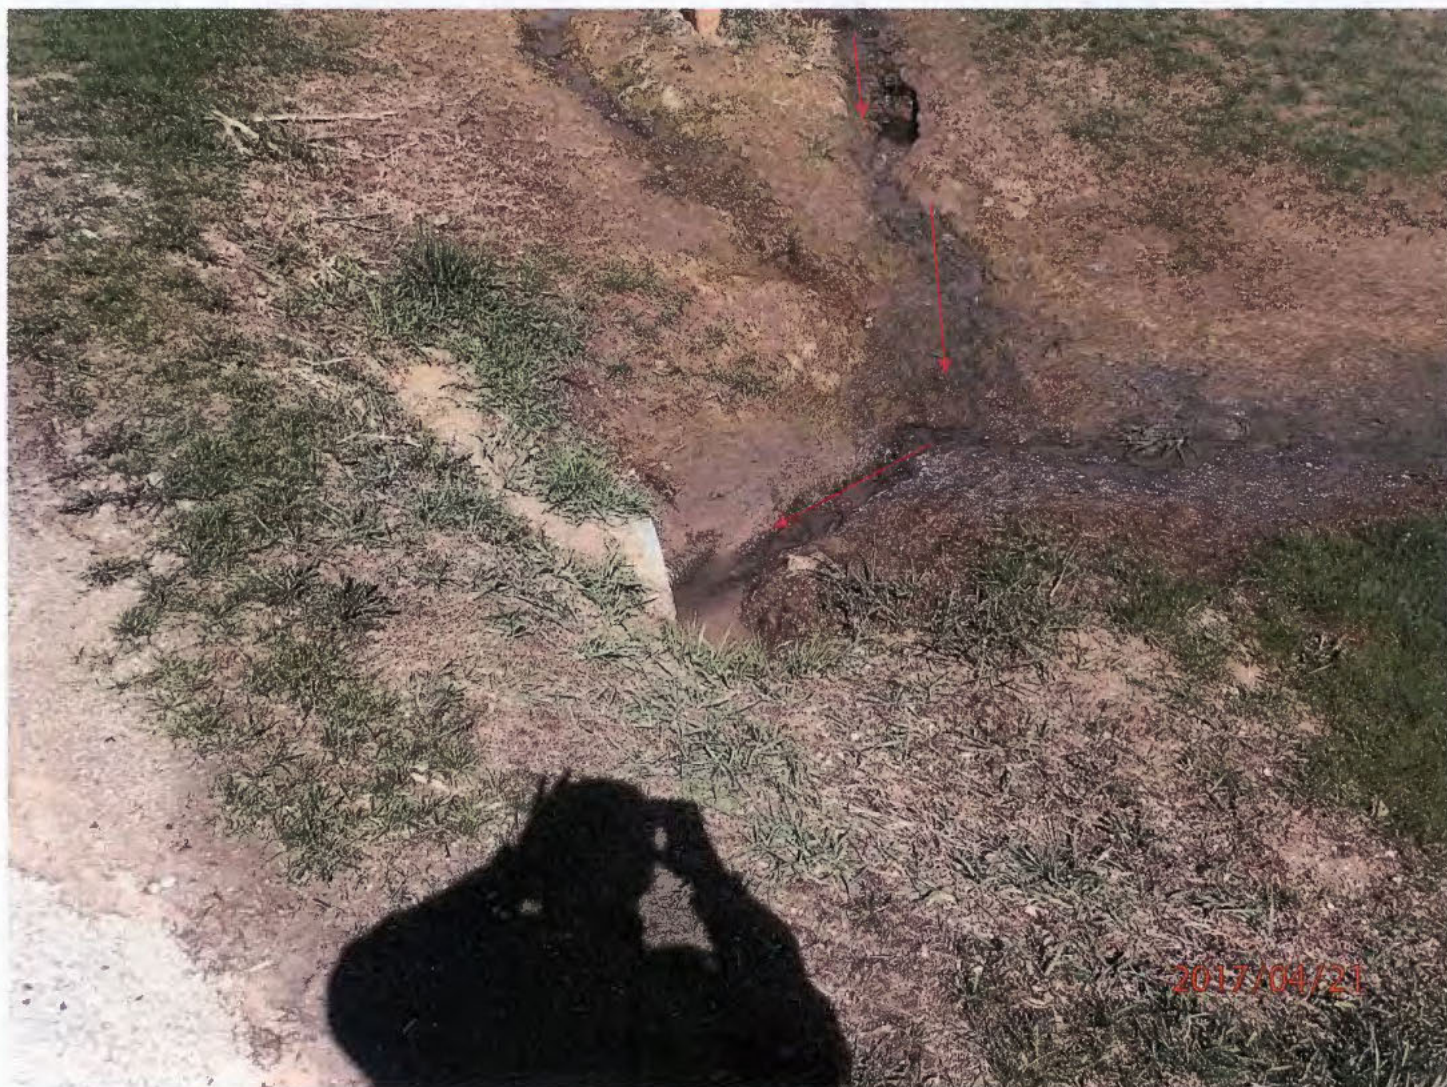
Photo: P4210091

Description: EPA observed the process wastewater that discharged from the silage pad flowing through the culvert under the 2nd driveway west of Lilac Lane.

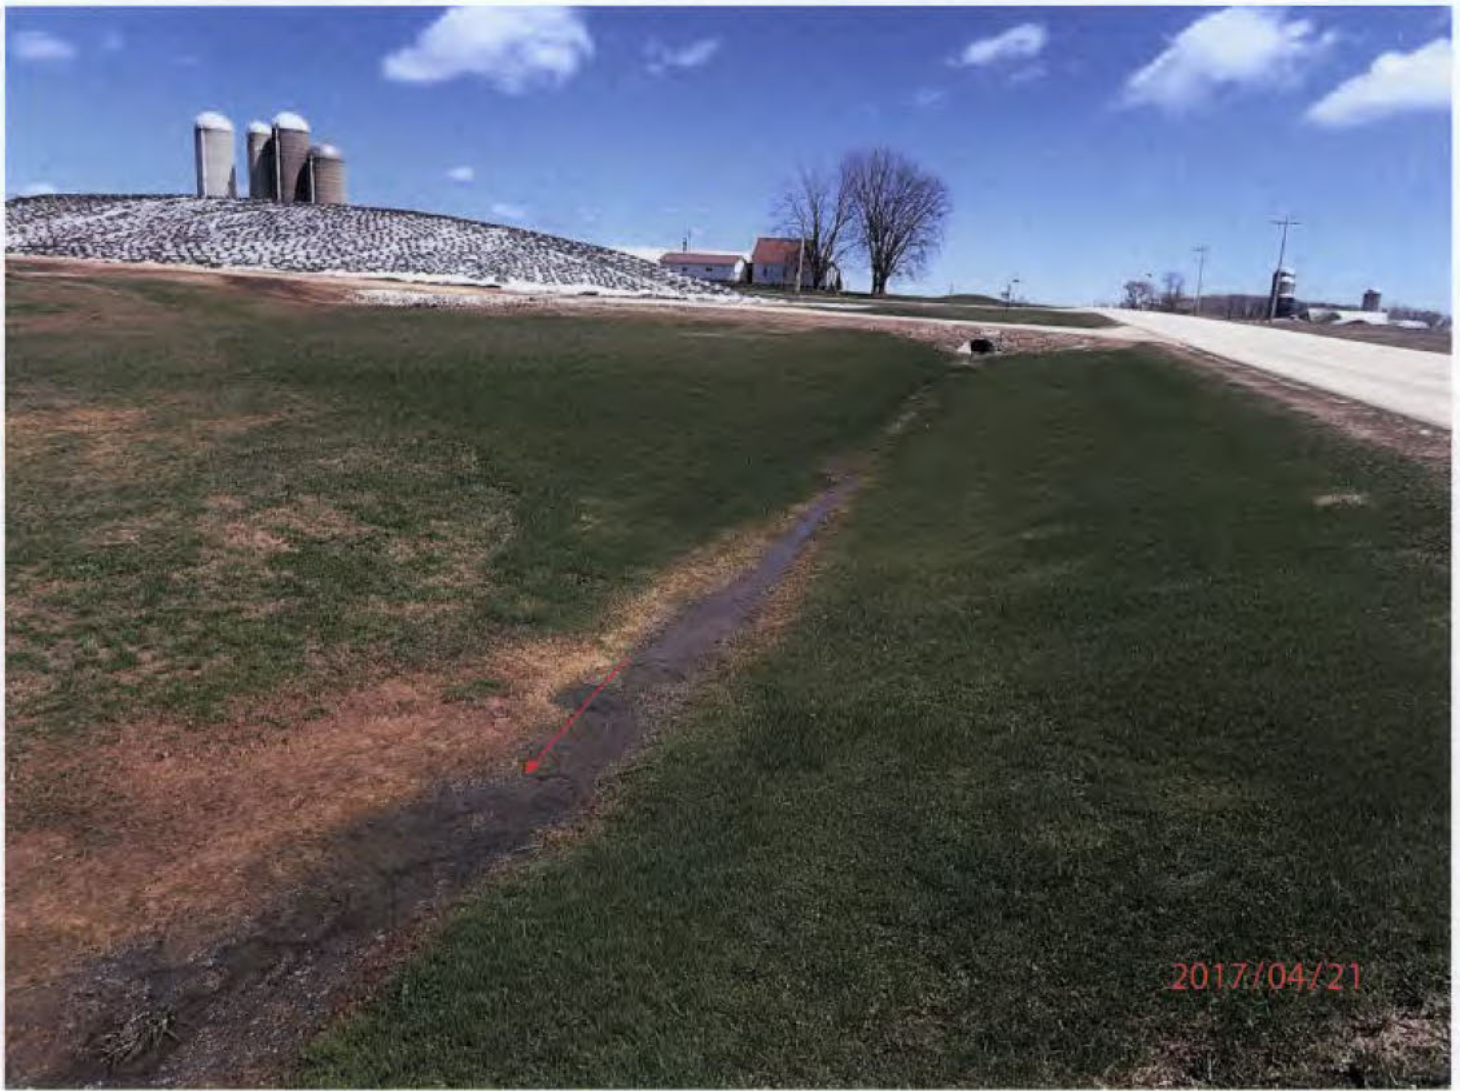
Photo: P4210092

Description: EPA observed process wastewater flowing in the roadside north of County Road F through the culvert under the 1st driveway west of Lilac Lane.
